Preliminary Information

PIC6436 No A/C - A/C Blows Warm Air - DTC P0534

Brand:	Model:	Model Years:	VIN:		Engine:	Transmissions:
			from	to		
Chevrolet	Bolt	2021	All	All	All	All

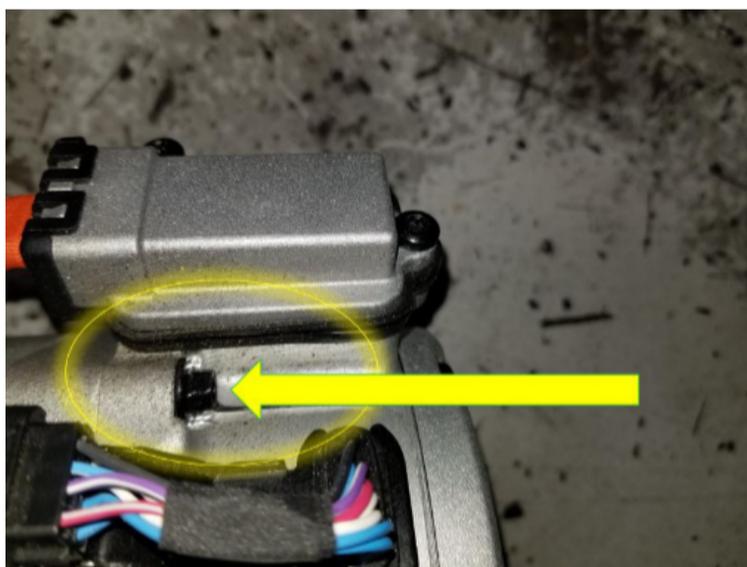
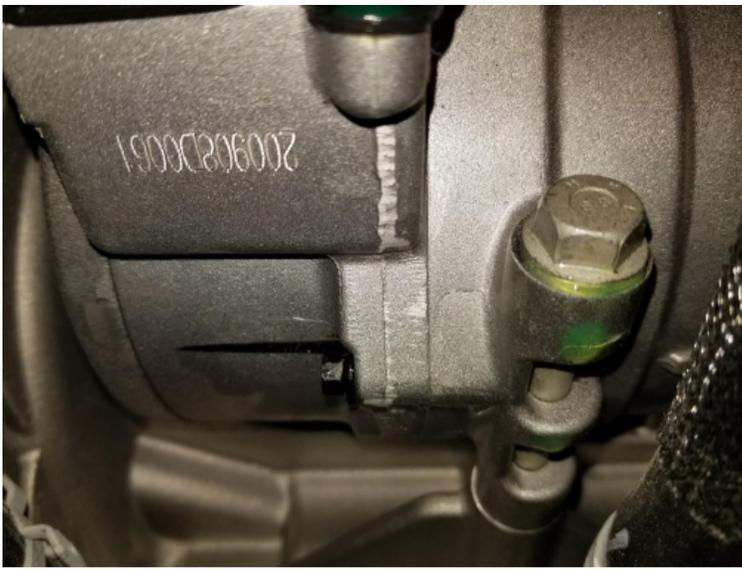
Involved Region or Country	North America
Condition	<p>No A/C, blows warm air when set to cold, Setting P0534</p> <p>Condition typically happens under 500 miles. Before adding refrigerant / dye, put car on hoist and remove aero panel from front cradle.</p> <p>Inspect the ACCM (Air Conditioning Compressor Module or sometimes called Air Conditioning and Drive Motor Battery Cooling Compressor), view the HV connector area for possible POE oil dripping off connector and the case bolt just above compressor.</p> <p>Refer to pictures below for existing oil leak examples.</p>
Cause	Defective ACCM K118 Electric ACCM internal seal, Oil visually leaking above HV connector at case half, see image below.

If this Concern is found continue to follow this document, if no leak is found continue with GSI diagnostics.

Replace K118 Electric ACCM GSI (Global Service Information, formally eSI) Document ID: 4530406
